RE: United States Environmental Protection Agency Comments on
"Brown Cover" Draft Public Health Assessment
South Dayton Dump and Landfill Site, Moraine, Ohio

**United States Environmental Protection Agency Comments on
September 28, 2007 "Brown Cover" Draft Public Health Assessment
South Dayton Dump and Landfill Site
November 19, 2007**

figure 2.1
SITE FEATURES/SITE INSPECTION
SOUTH DAYTON DUMP AND LANDFILL SITE
Moraine, Ohio

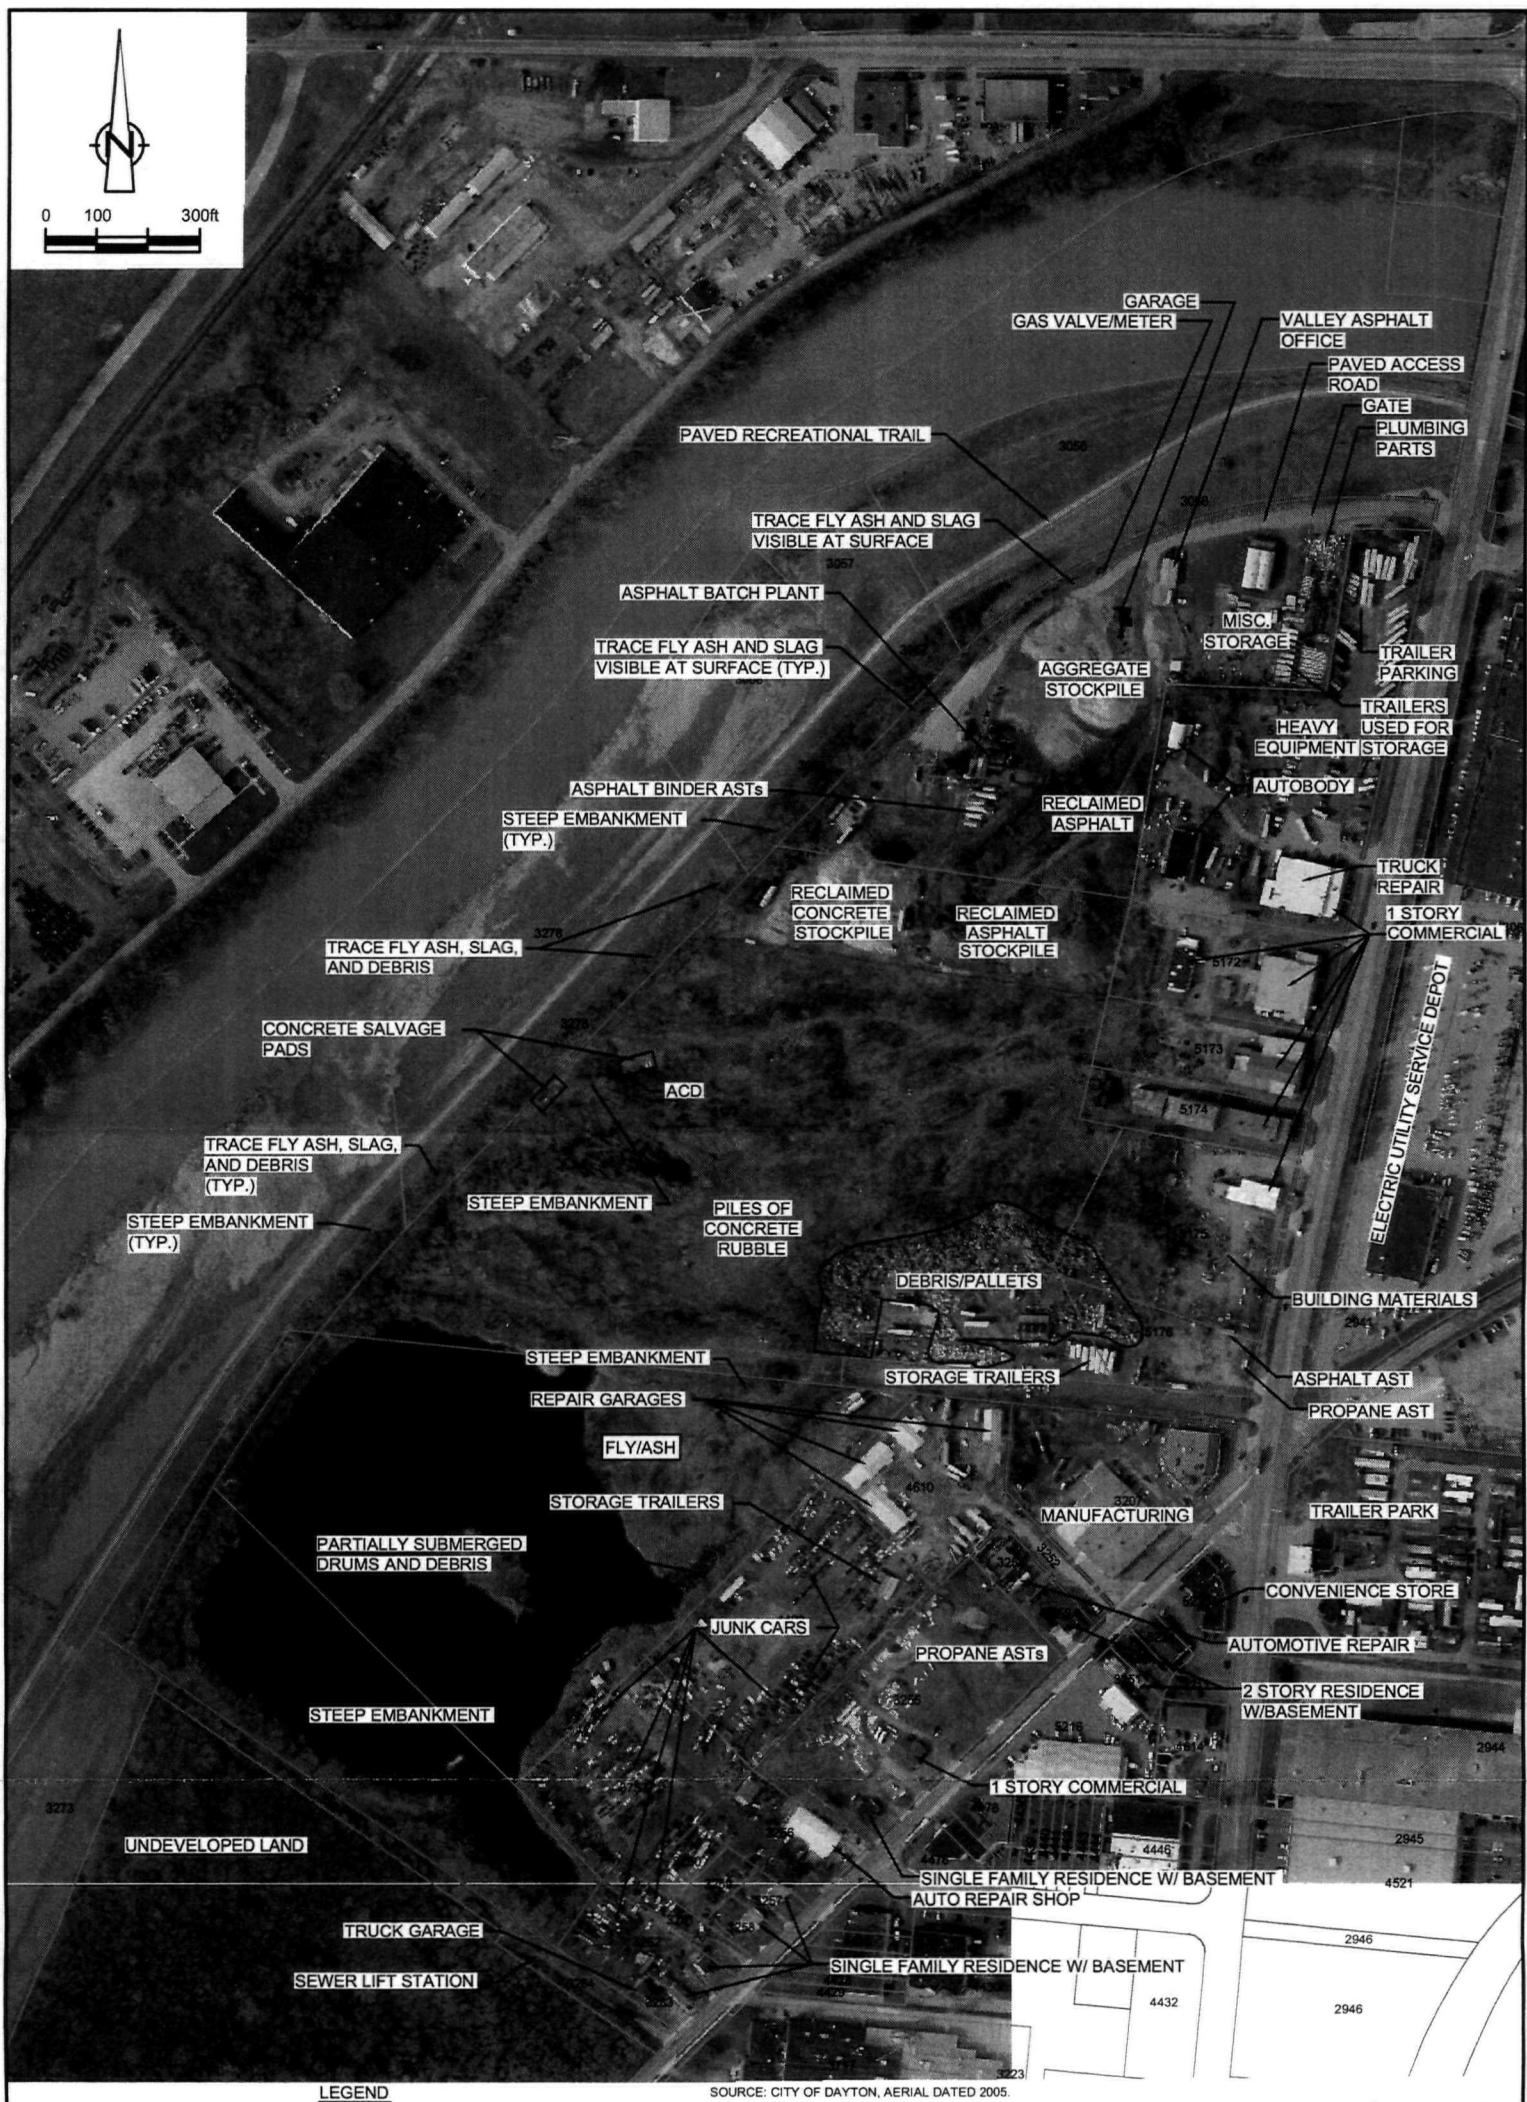
The physical setting section presents a description of current Site conditions. Figure 2.1 presents Site features.

2. Page 2, Summary, Paragraph 3: Soil sample S08 (OEPA) collected from 0.2-0.3 feet below ground surface in 1996 contains elevated levels of lead (652 mg/Kg) and copper (1,830 mg/Kg) as well as antimony (278 mg/Kg), arsenic (141 mg/Kg) and polynuclear aromatic hydrocarbons (PAHs) including 820 ug/Kg benzo(a)pyrene [see Ohio Environmental Protection Agency (OEPA) 1996 Site Team Evaluation Prioritization Report]. Sample S08 (OEPA) was collected from the embankment leading down to the Great Miami River (GMR) on Miami Conservancy District (MCD) property (Lot 3278) and indicates landfill contaminants are leaving the South Dayton Dump and Landfill (SDDL) and/or the landfill extends into off-Site areas. Conestoga Rovers Associates (CRA), the consultant for the SDDL potentially responsible parties (PRPs) reports the embankment is constructed of fill material including slag, ash and foundry sand and metal and glass shards. Sample S10 (EPA) collected from the embankment on MCD property north of S08 (OEPA) (Lot 3058) also contained 1,200 ug/Kg benzo(a)pyrene (see Draft RI/FS Work Plan Pages 5, 18, 76, and 78; Figure 2.1 (site features/inspection); Figure 2.20 (soil sample locations); and Table 2.2 (soil sample results) in Attachment 2. NOTE: "Direct Contact Presumptive Remedy Area" in Figure 2.1 and Figure 2.20 is not approved; please disregard.

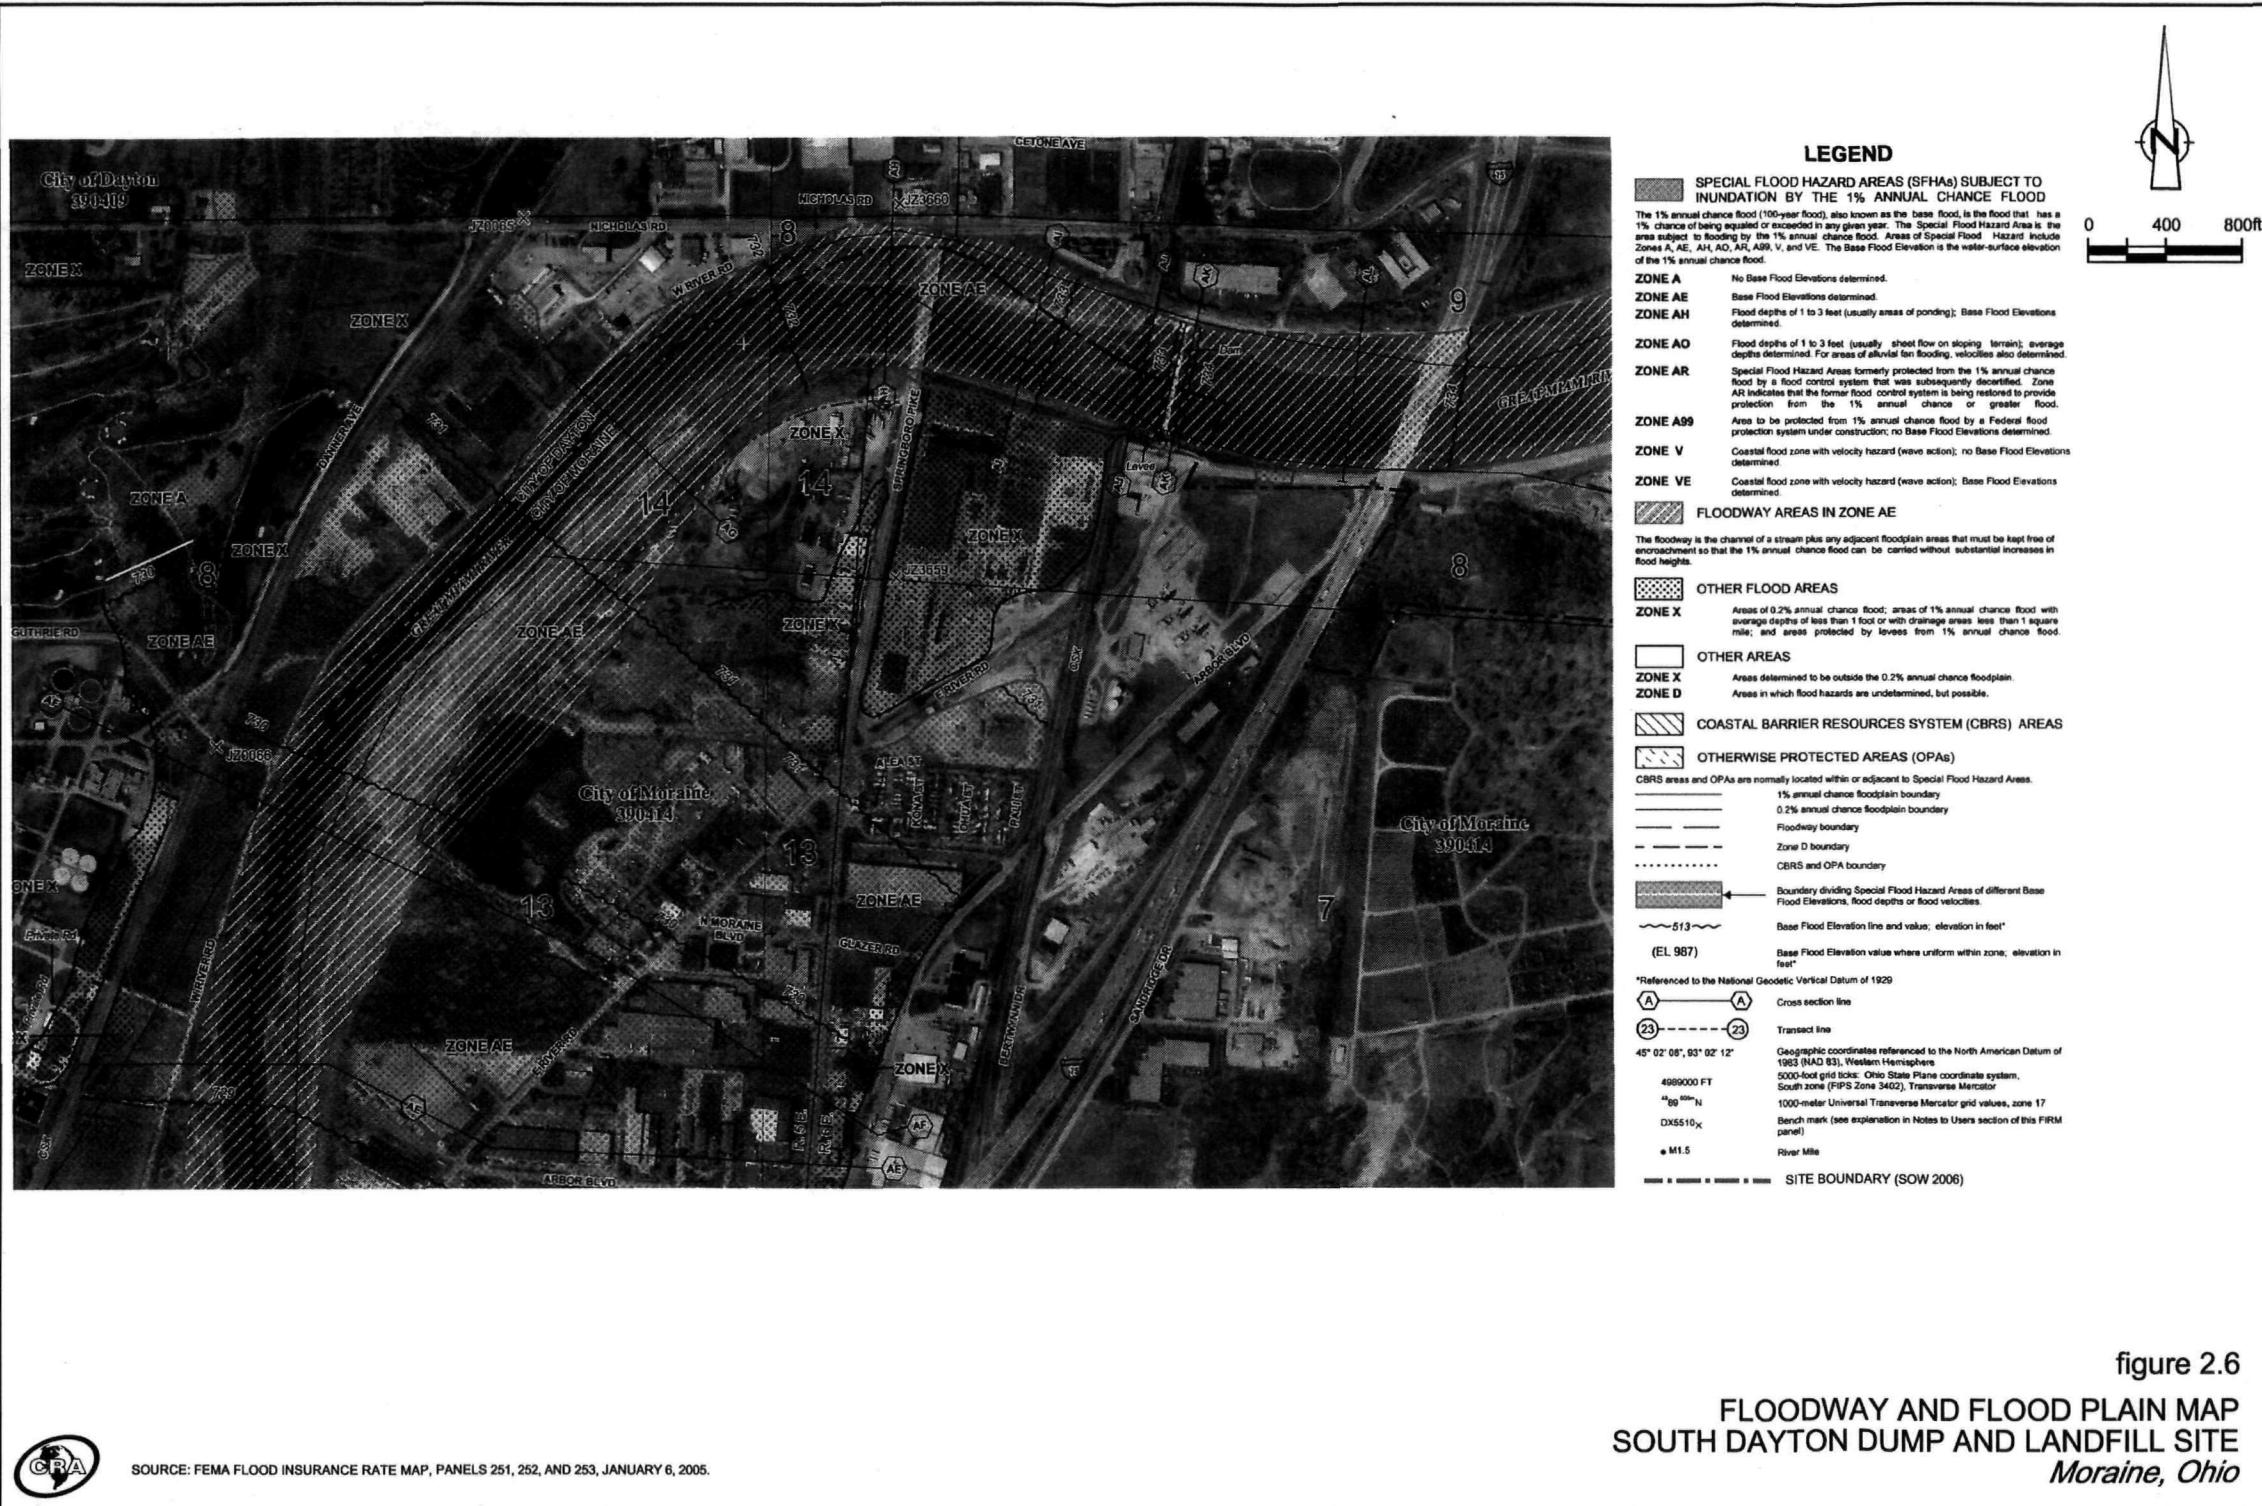
figure 2.6

These chemicals were also detected at much higher concentrations on Site. About 10 percent of the landfill is in the 100 year floodway and about 60 percent of the landfill is in the 100 year floodplain (Draft RI/FS Work Plan Figure 2.6 in Attachment 2). About 50 percent of the landfill is below the 10 year flood elevation which ranges from 729 feet north of Dryden Road to 726 feet south of the Quarry Pond (see Draft RI/FS Work Plan Page 32 in Attachment 2 and Payne Firm Survey in Attachment 3).

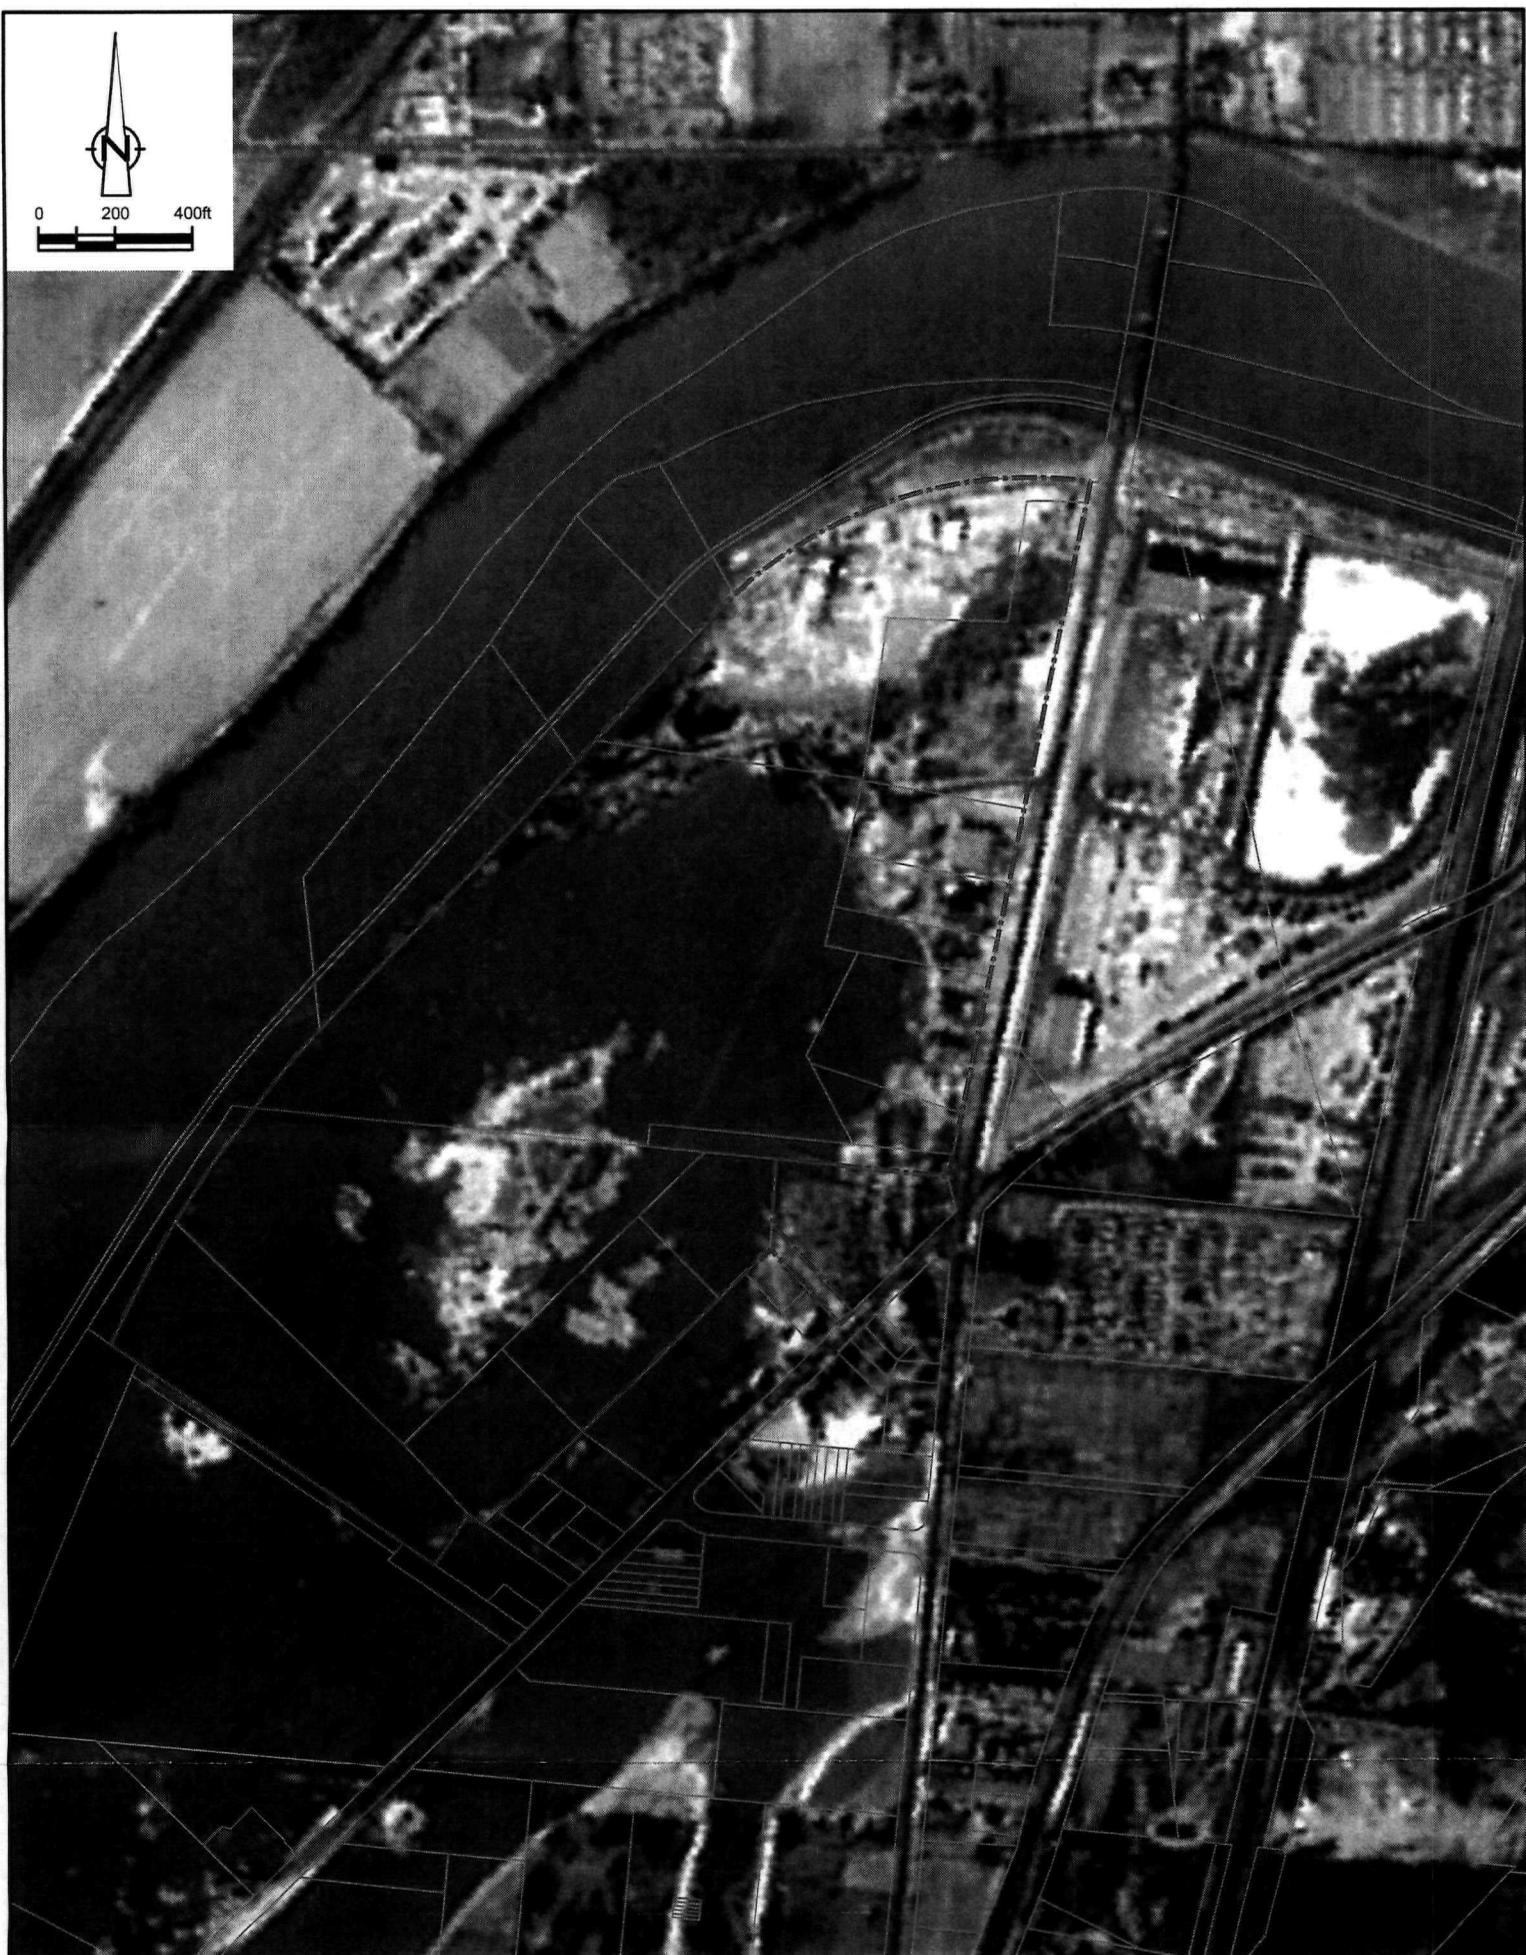
figure D-5

Draft RI/FS Work Plan Figure D-5 shows the extent of Site flooding during a 1959 flood (Attachment 2, Appendix D). The 1959 flood was between a 20 to 50 year flood event and is estimated as a 40-year flood with a maximum daily average discharge of 57,100 cubic feet per second (cfs) at the nearest upstream gauging station (USGS Dayton 03270500) (Attachment 4).

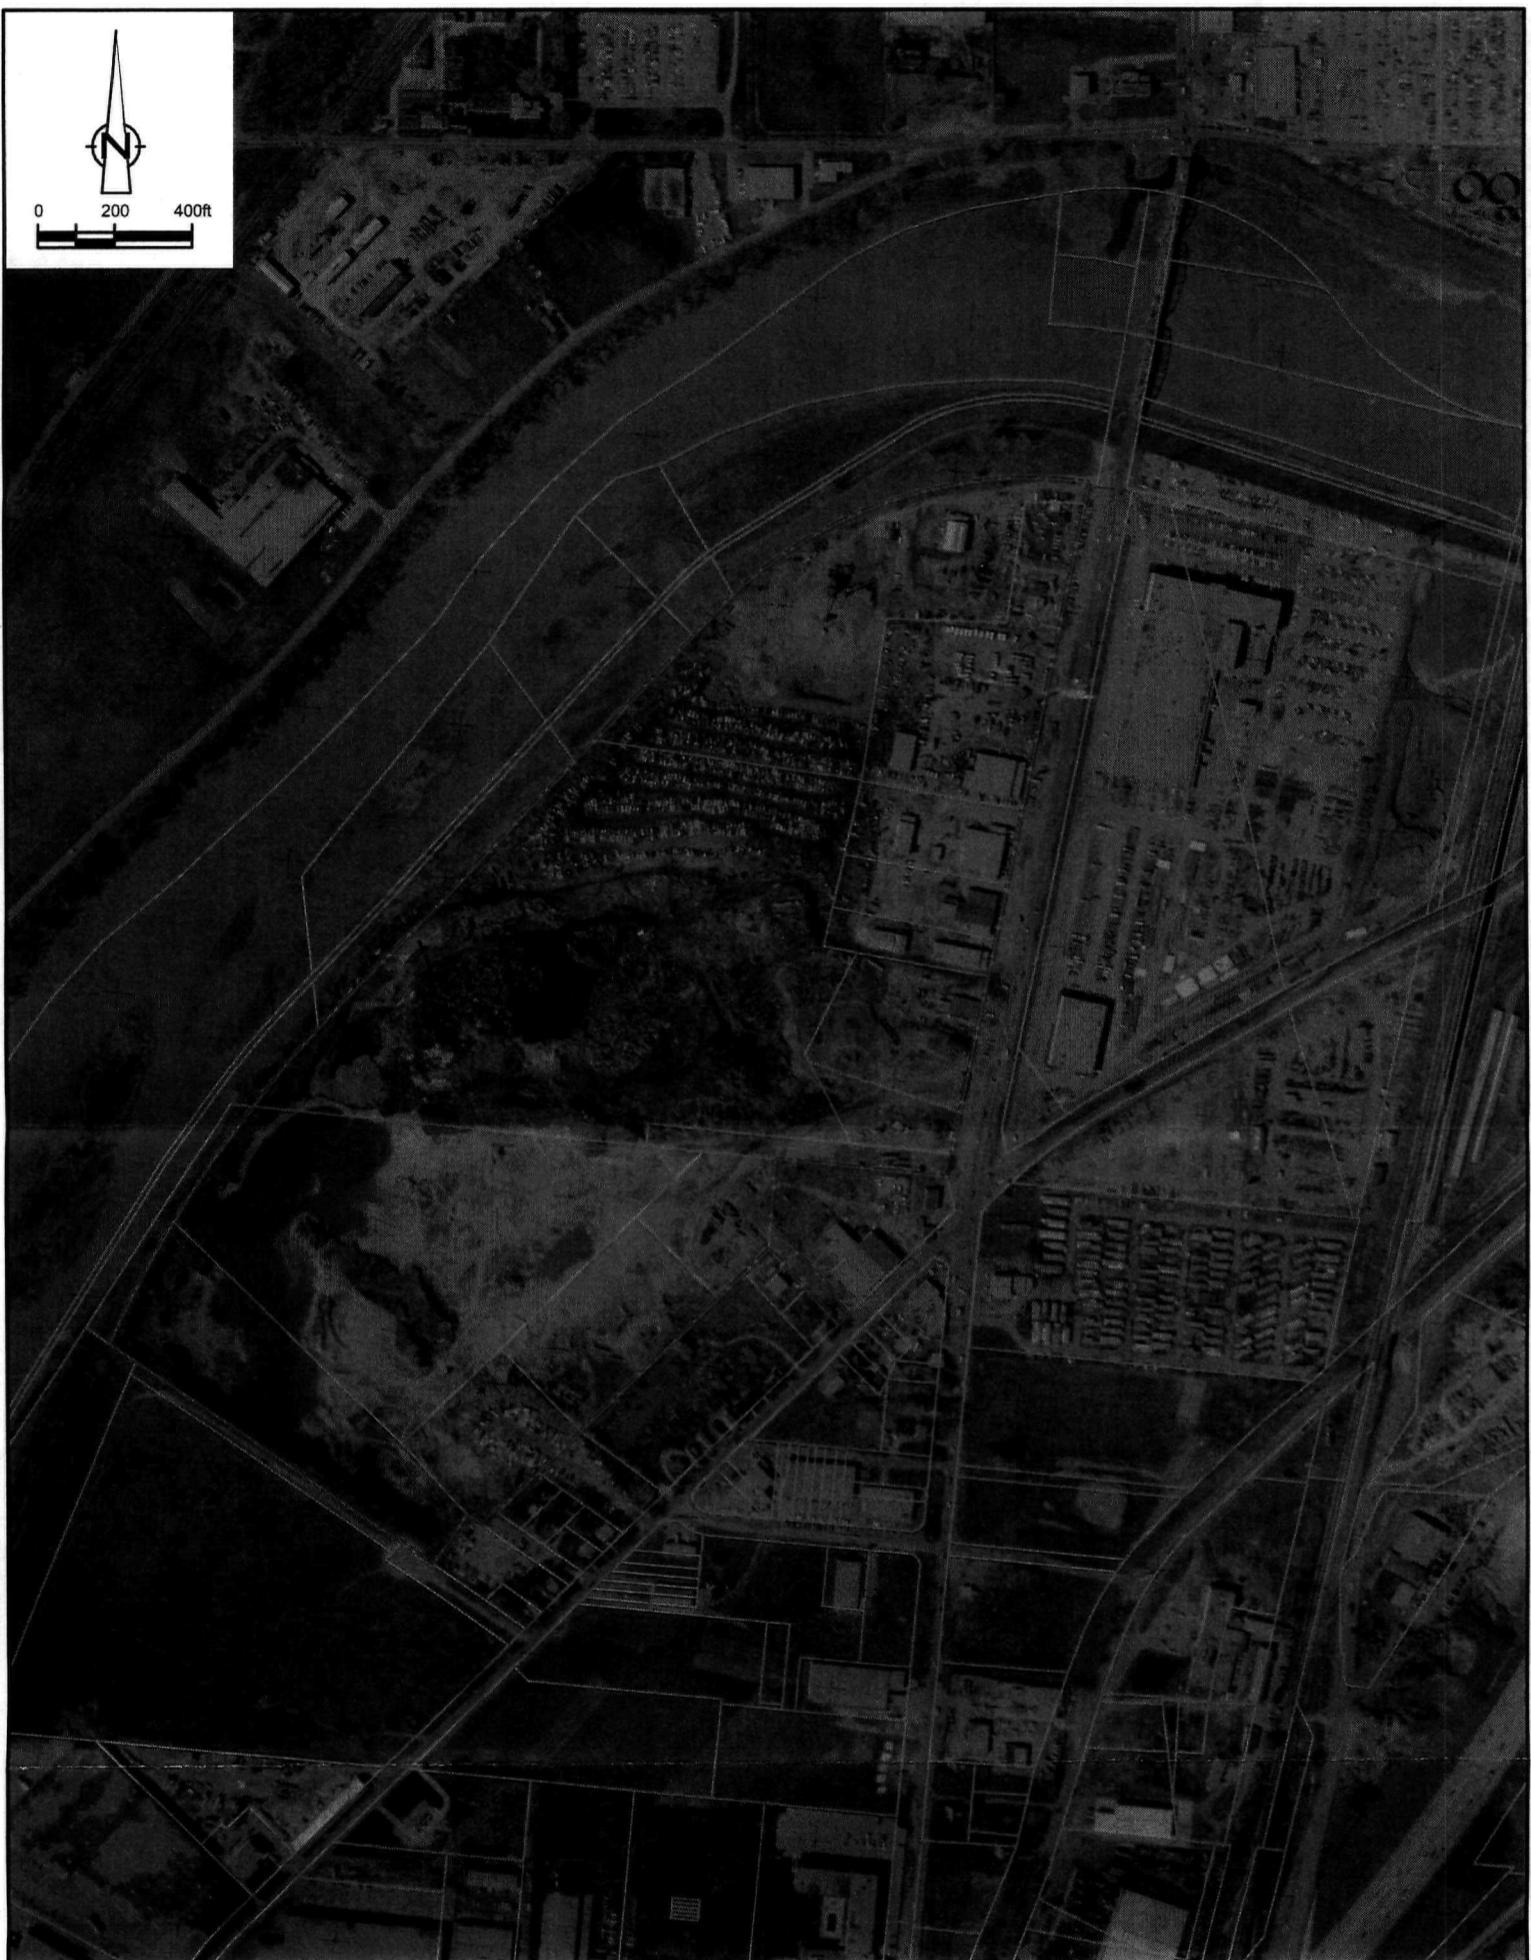
An air photo from April 14, 1973 (Attachment 2, Draft RI/FS Work Plan Appendix D, Figure D-9) shows flooding along the MCD recreational trail to the embankment of the landfill in some Site areas. United States Geological Survey (USGS) records indicate the maximum daily average discharge on April 14, 1973 was 7,190 cfs with a maximum daily average discharge for the event of 8,220 cfs on April 13, 1973 (Attachment 4).
